Hazards Evaluation of the Newhall Ranch Habitat Management Plan and Spineflower Conservation Plan Project

September 30, 2008

ENTRIX, Inc.
2140 Eastman Ave, Suite 200
Ventura, CA 93003

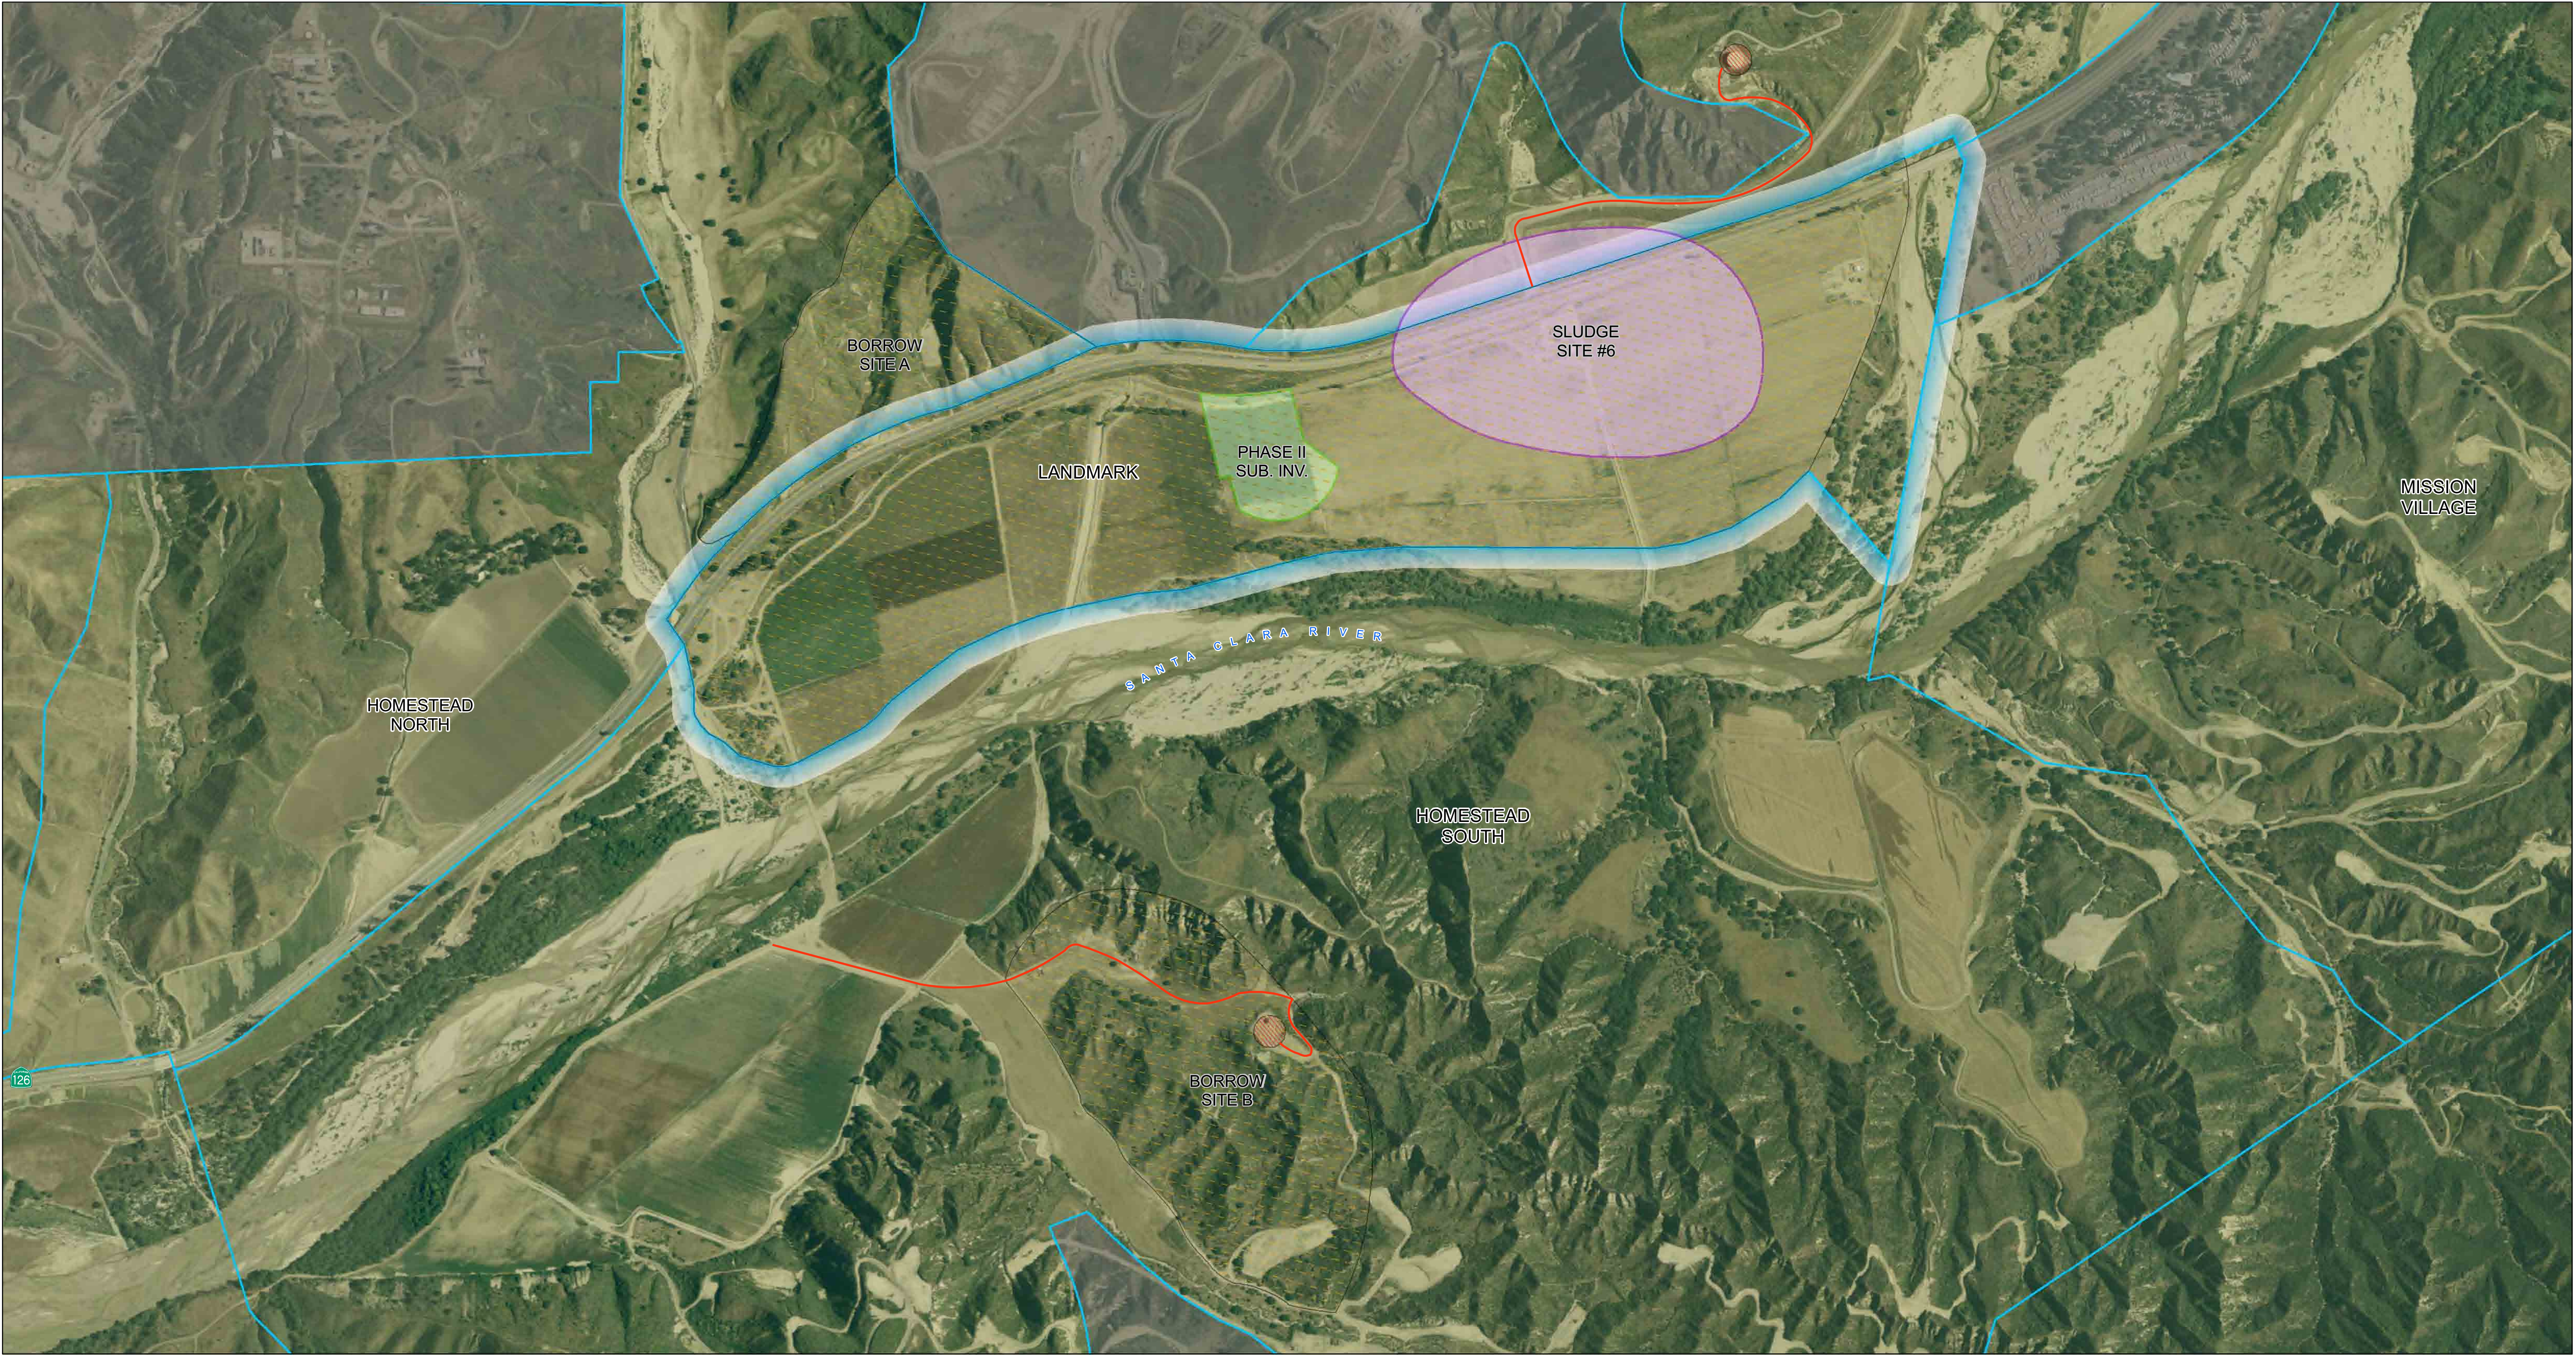
Figure A-7

Landmark Village Specific Plan Area
Environmental Assessments
and Investigations
